# BOOMERANG

## WIRING DIAGRAM CORRECTION

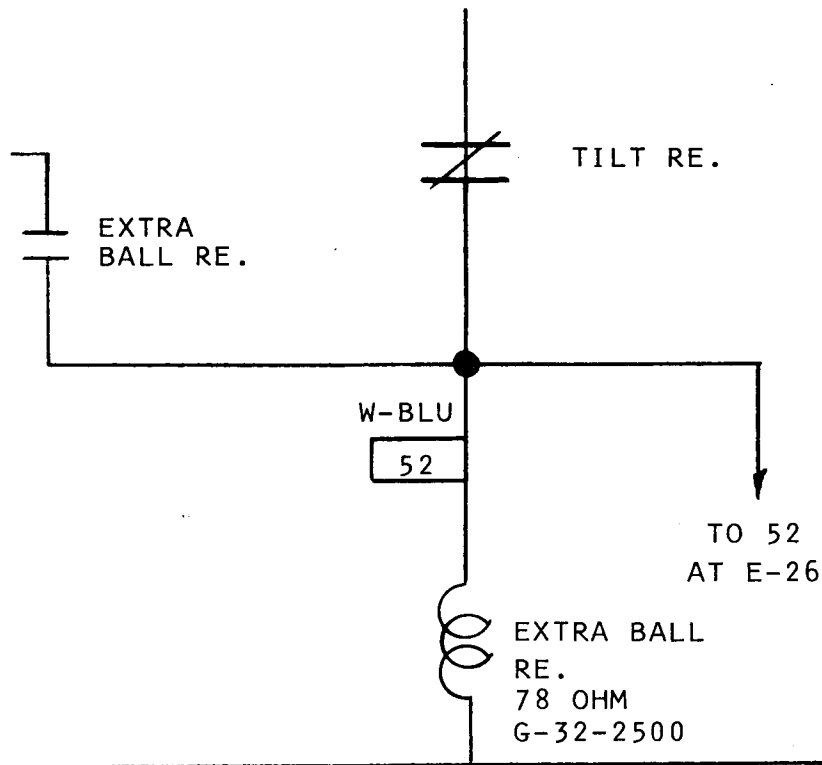
LOCATION F - 9

CORRECTION:  
THE EXTRA BALL RE.  
SHOULD READ AS  
SHOWN.

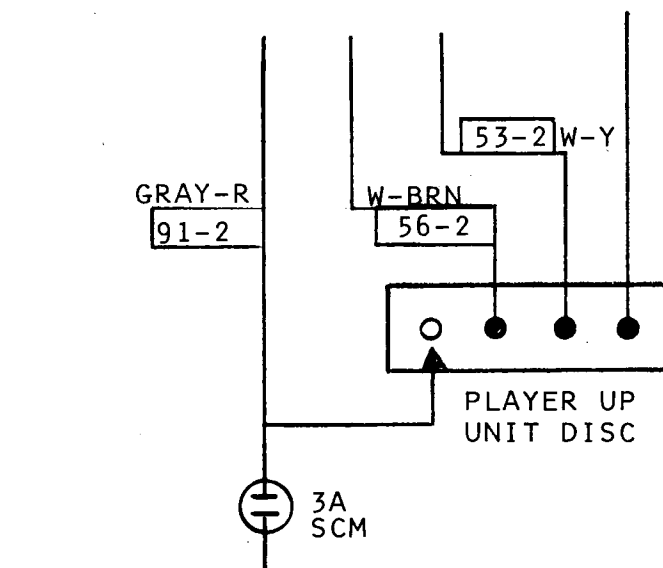
LOCATION D - 18

CORRECTION:  
THE PLAYER UP UNIT  
DISC IS NOT IDENTI-  
FIED AS SUCH.
