## NO GOOD GOFERS

### Ball Hang-up Field Repair Kit # A-22599

Known problems, adjustments, reported ball traps errata work sheet.

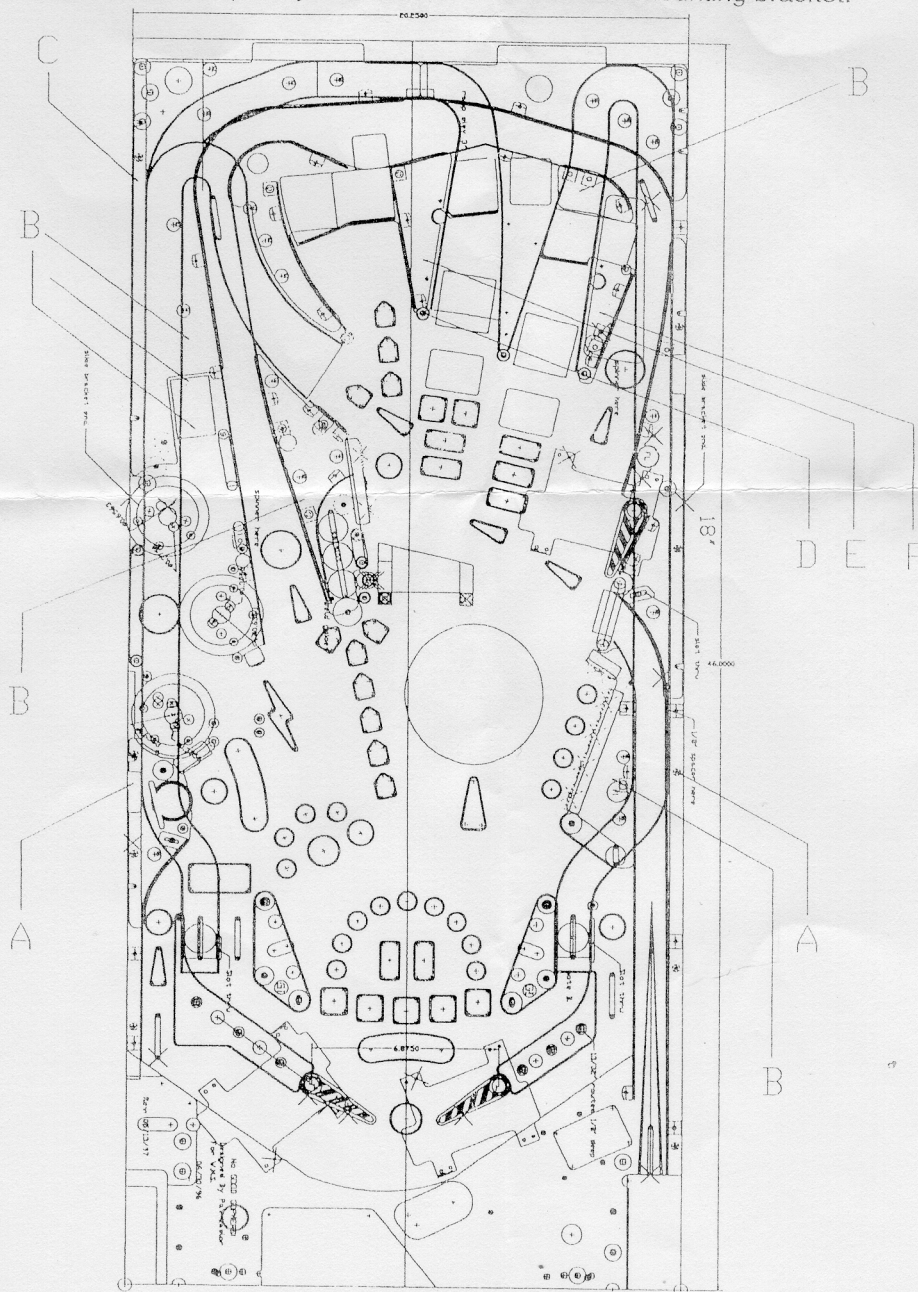
Use the included playfield diagram for key locations.

1. Part # 01-15003 can be screwed to the ramp mounting locations at "A" to eliminate a ball trap against the lower ramp flasher domes.
2. Part # 01-15002 should be installed on the left side of the slam ramp to avoid a ball being trapped between a lowered slam ramp and the captive ball plastic. To install this part remove top screw and washer from the left slam-ramp rubber post. Slide the trap guard into the slam ramp so that the hole in the guard lines up with the hole in the post screw. Re-install the screw and washer so that both parts are held securely.

3. The left upper flashlamp bank wiring may be incorrectly dressed. The wiring should be run BETWEEN the flashlamp bank rear mounting post and the cabinet and not in front of it.

4. The following will eliminate the possibility of a trap occurring between the wiring and the side of the cabinet at location "C". On some games the plastic mounted over the back-trap area is too high at its front tip making it possible for a ball to get trapped underneath it at location "E". Move the driving range for clearance to this area by taking out its single mounting screw. At location "D", clip the point (approx. ¼") off of the plastic using a wire-cutter. Remove the screw in the post that was under the point of the plastic and discard it. In its place install #4700-00070-00 washer and #4008-01005-06 screw. The shoulder of the washer will come down on the tip of the plastic and hold it in place.

5. On some games there may be a ball trap between the right upper flashlamp bank and the side of the ramp under it. At point "F" remove the screw holding the LEFT red anti-trap mini-post. (This post is mounted upside down to the right of the ramp entrance.) Install #31-3229 plastic and (2) # 03-9255-2 spacers with a # 4106-01001-16 screw back into the anti trap post. The post acts as a nut.
6. There are several places where a ball may come to rest depending on the pitch and angle of the game. Included in the kit are (6) #23-6828 self sticking rubber bumper pads. These can be installed in the following locations, "B".

Just behind the right mounting nut for the left spinner.

Just below the lower curve of the right ramp.

At the intersection of the red hole-in-one lip and upper right flash lamp bank on the driving range.

On the side of the left ramp just above the left ball popper.

On the top of the left ball popper near the end of its nose.

On the top of the left ramp rail just behind the micro-switch mounting bracket.
